# Sony Vaio PCG-71713L Hard Drive Replacement

The hard drive is replaced due to malfunctions and/or defects.

Here you will learn how to replace the hard drive on a Sony Vaio PCG-71713L Laptop.

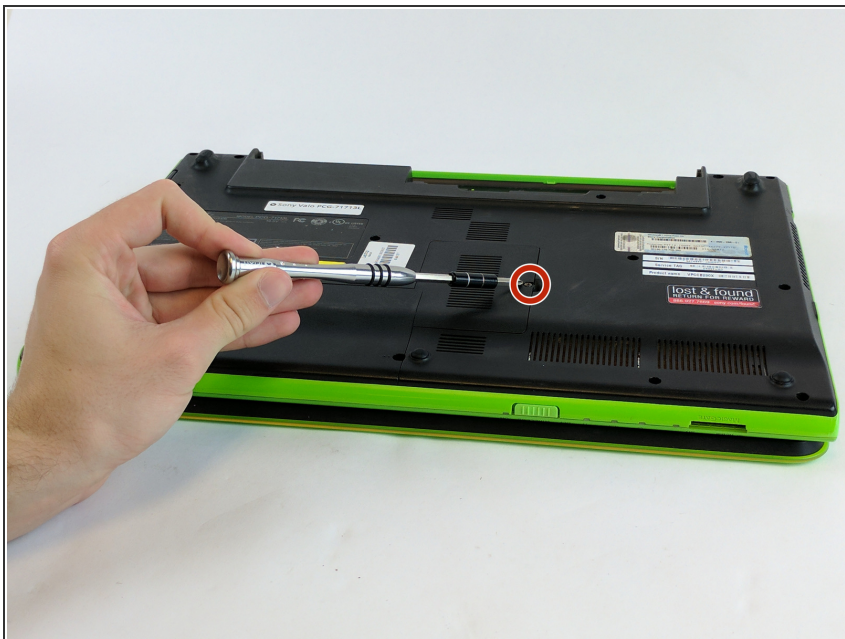
## Step 1 — Hard Drive

- First remove screws from the plastic cover on the bottom of the device using a Phillips head #1 screw driver.

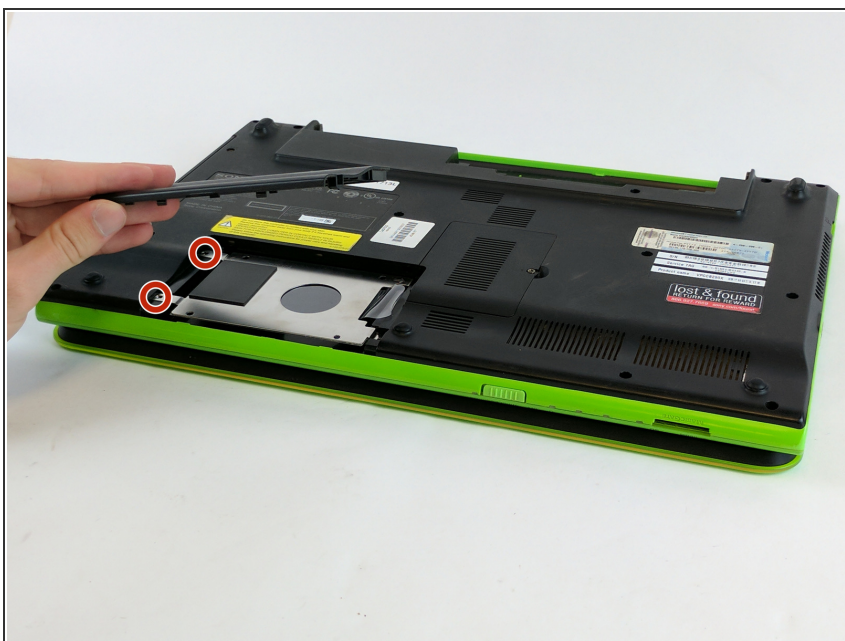
## Step 2

- Remove the screws that hold the hard drives metal tray in place. Use a spudger (as seen in the photo) to lift up the hard drive's metal tray.

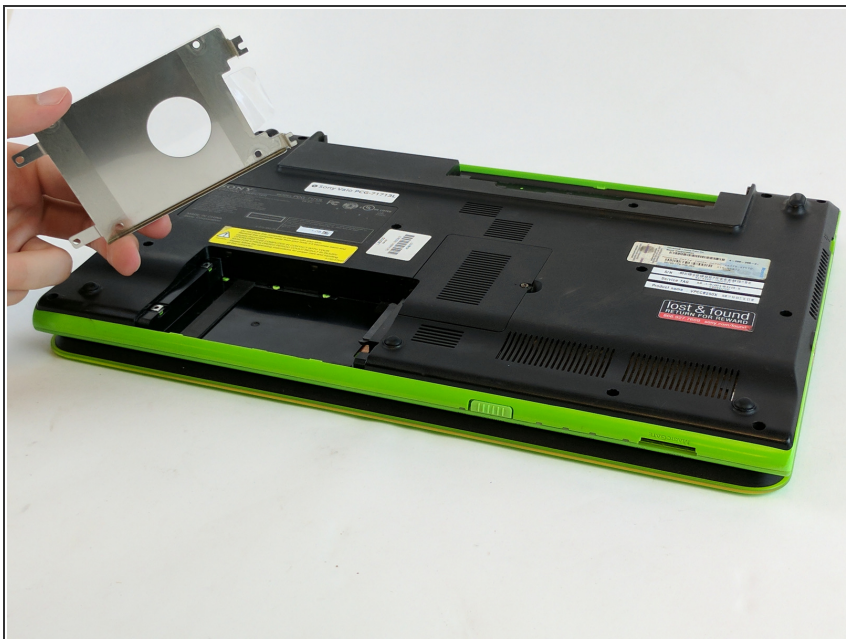
## Step 3

- Remove the metal tray and the hard drive which is attached to it.
